**PROGRESS REPORT NO. 1
8 DECEMBER 2010**

THIRLMERE LAKES

PROGRESS REPORT NO.1

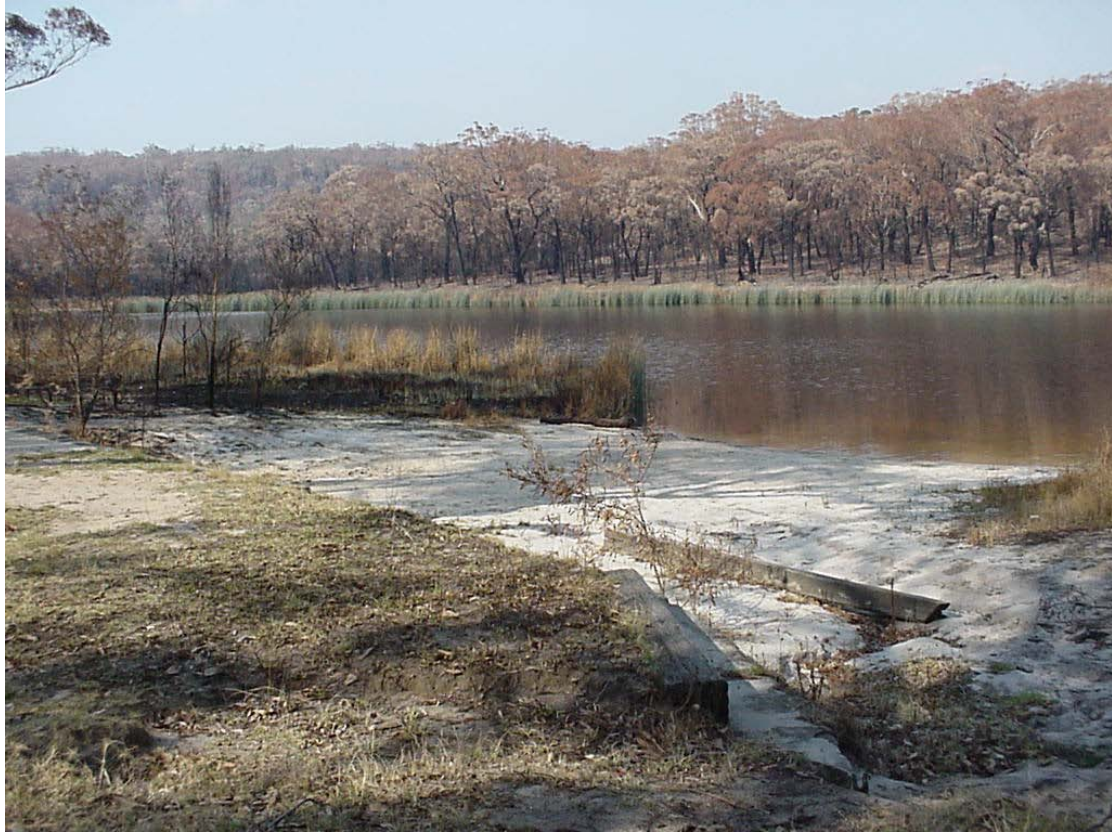
Photograph 3: 4 October 1998, Jeff Patchett photograph.
(Same location as Photo 2, pier had been burnt down).

THIRLMERE LAKE LEVEL OBSERVATIONS				
YEAR	DATE	LAKE NAME	OBSERVATION	PERSON OR DATA SOURCE
1998	4/10/98	Werri Berri	Water level about 1m below end of jetty.	Jeff Pratchett (Tahmoor local).
2002	10/01/02	Werri Berri	After fire. Jeff comment: "Taken in the same post after the water level dropped, jetty burnt, which by this time was well out of water. I stand at 6ft and the water was well over my head, back in 1998 when you climbed up the ladder. At least a 7ft fall in the four years."	Jeff Pratchett (Tahmoor local).
2002	?/?/02	Nerrigorang	Lake appears to be lower (but hard to tell due to burnt reeds)	Olive Johannessen photo x 4 (c/o Caroline Graham)
2005	20/12/05	Werri Berri	Full	Dept Lands Air Photo
2005	20/12/05	Couridjah	>95% Full	Dept Lands Air Photo
2008	13/06/08	Werri Berri	Water level high	Julie Shepard photo of canoe
2009	31/10/09	Werri Berri	At 76% of full width at the widest part	Google Earth photo

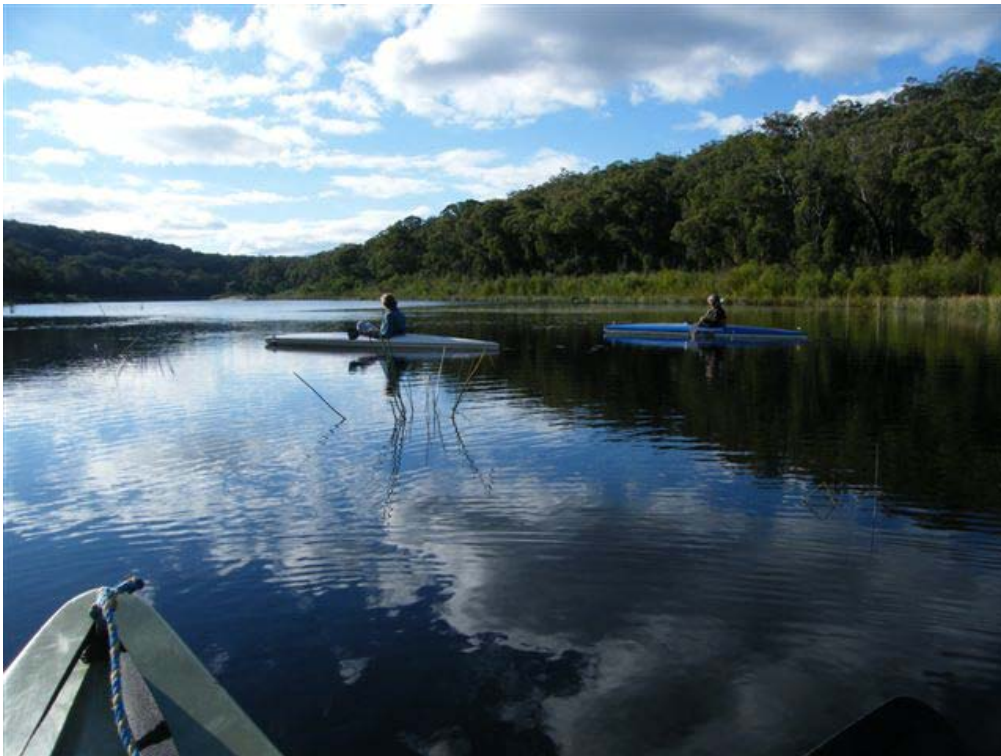
Photograph 4: Werri Berri June 2008, Julie Sheppard photograph.

THIRLMERE LAKE LEVEL OBSERVATIONS			
DATE	LAKE NAME	OBSERVATION	PERSON OR DATA SOURCE
22/03/66	Werri Berri	Full	Dept Lands Air Photo
22/03/66	Couridjah	Full	Dept Lands Air Photo
2/04/75	Werri Berri	Full	Dept Lands Air Photo
2/04/75	Couridjah	Full	Dept Lands Air Photo
27/10/83	Werri Berri	Full	Dept Lands Air Photo
27/10/83	Couridjah	Full	Dept Lands Air Photo
10/04/89	Couridjah	Full	Hunt photo
30/11/89	Couridjah	>95% Full	Hunt photo
4/01/94	Werri Berri	Full	Dept Lands Air Photo
4/01/94	Couridjah	90% to 95% Full	Dept Lands Air Photo
20/12/05	Werri Berri	Full	Dept Lands Air Photo
20/12/05	Couridjah	>95% Full	Dept Lands Air Photo
13/06/08	Werri Berri	Water level high	Julie Shepard photo of canoe

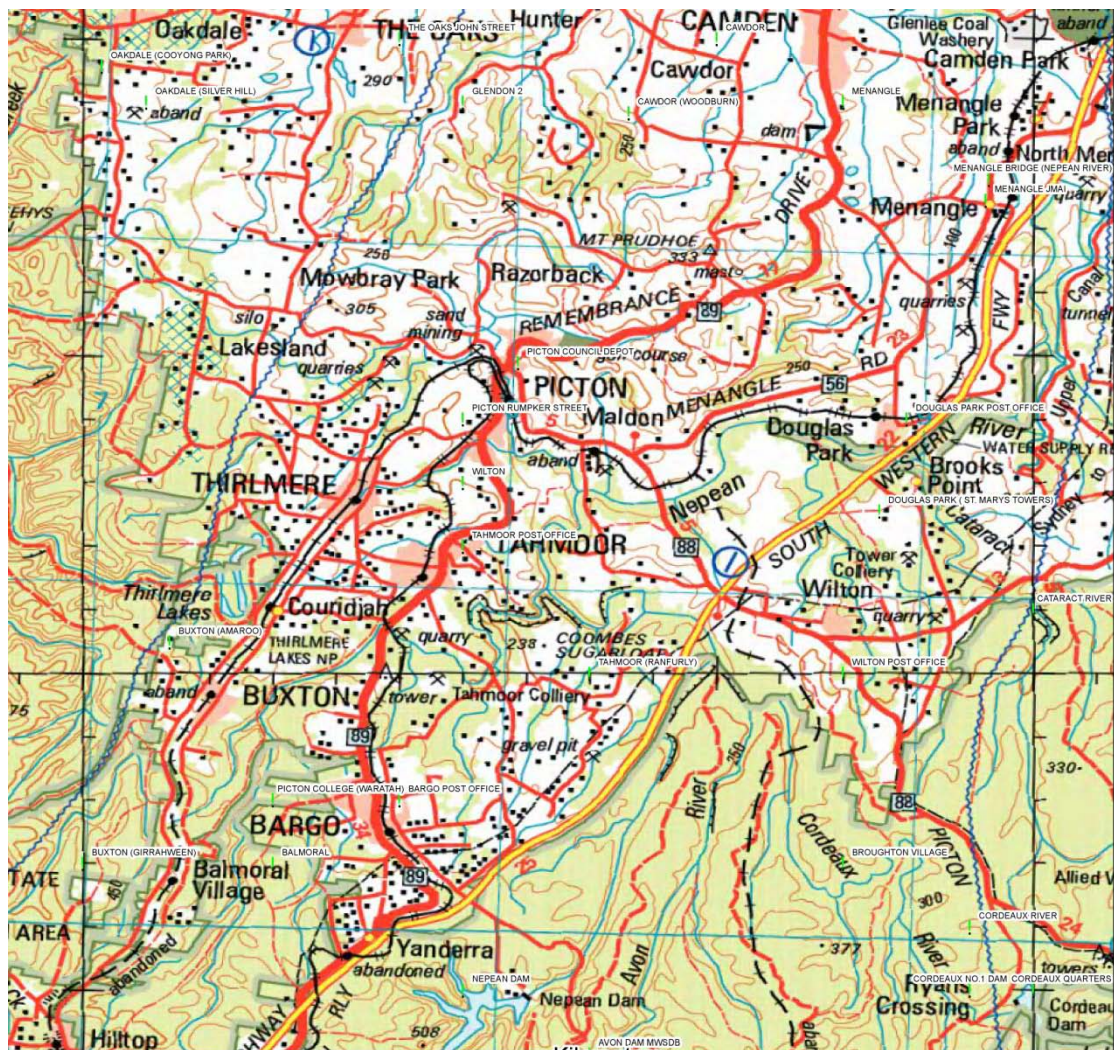
Figure 6: Rainfall station locations.

Figure 6 shows the rain gauge locations within about 20 kilometres of Thirlmere Lakes. Table 1 summaries the closest station to the lakes.

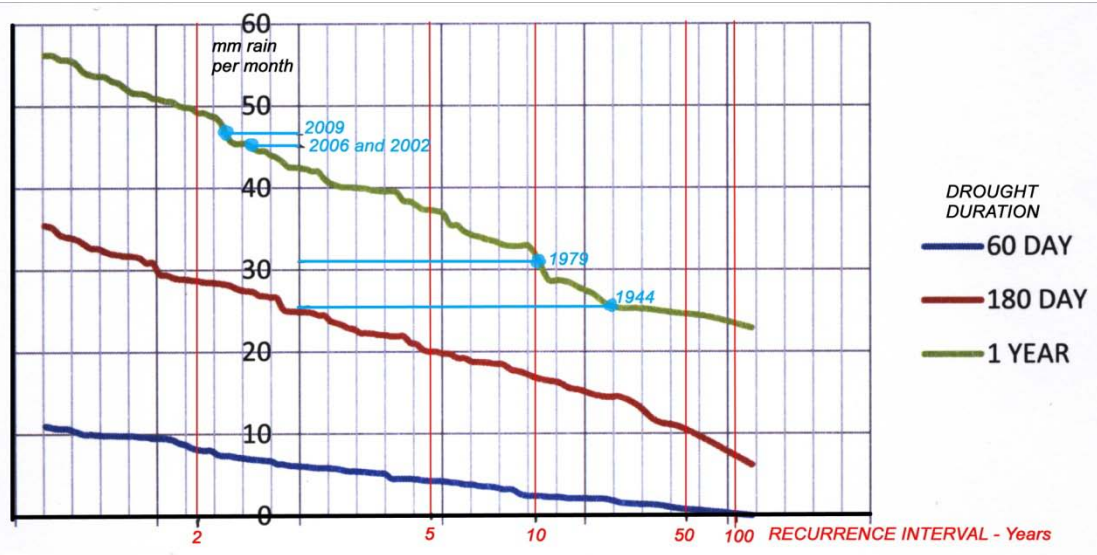
Figure 7: Drought Recurrence Duration Plot.

Figure 7 shows the preliminary drought recurrence interval plot, together with the recorded annual rainfalls in 2002, 2006 and 2009.

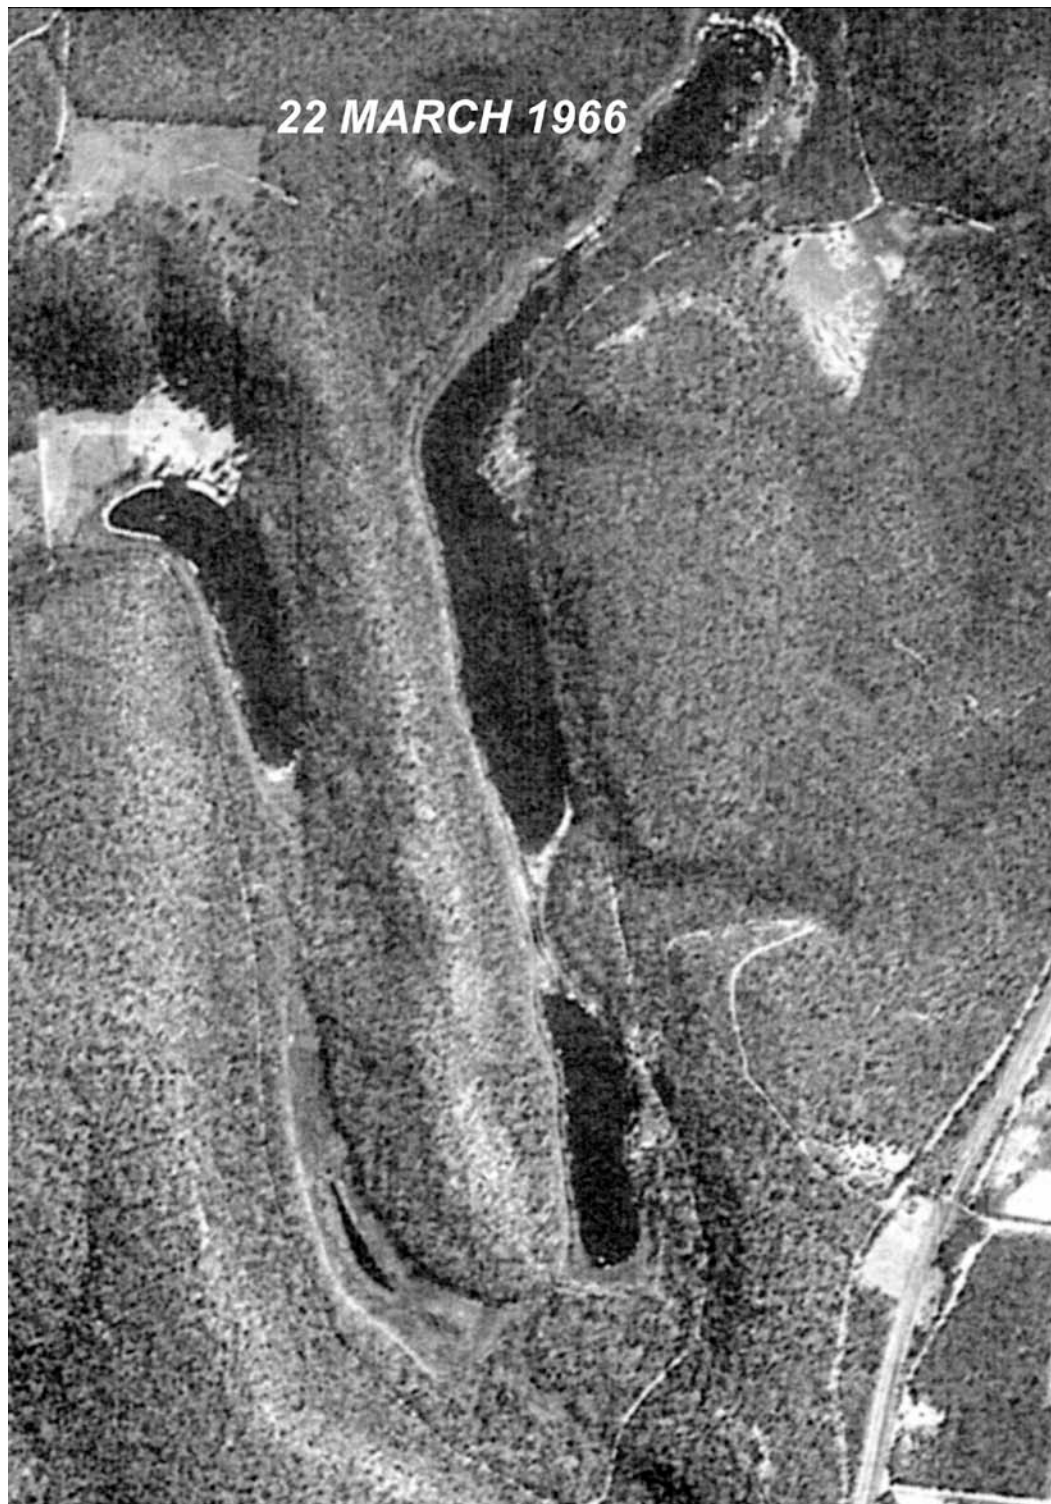
Figure 2: 22 March 1966.

In addition, aerial photographs are available on Google Earth for 2009 (partly obscured) and 2010. The relevant portions of these photographs have been extracted and reproduced in Figures 2 – 8 below.

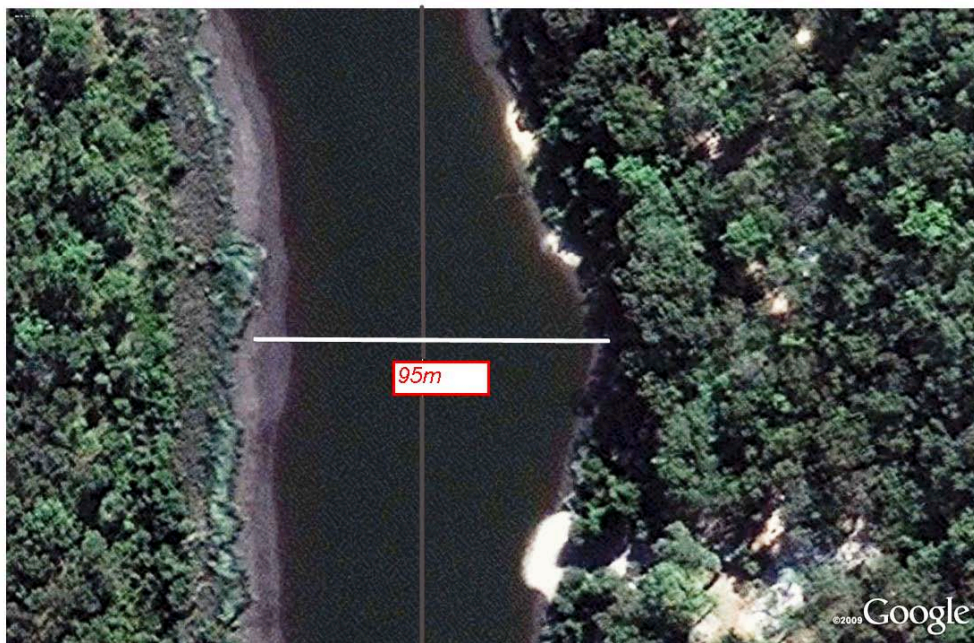
Figure 14: Lake Couridjah – 13 April 2010

It is not possible to determine the volume of water stored in the lakes at different times. So it has been decided to express the amount of water stored in the lakes by comparing the widths of the stored waters with the maximum widths, at the different times. Figures 14 and 15 show the points in Lakes Couridjah and Werri Berri, here the widths have been used to express the amount of water stored at different times.

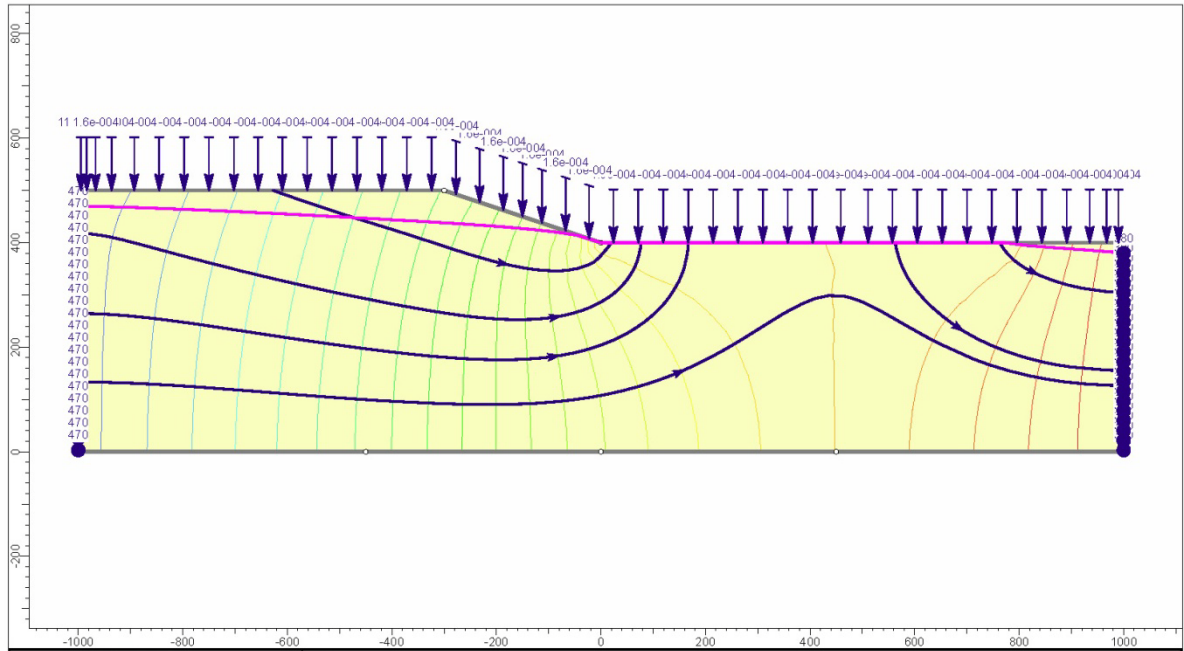
Conceptually, and in two dimensions, the groundwater flow system above a very simplified version of Figure 2 is as per Figure 3a and Figure 3b.

Fig 3a: flow regime prior to mining; 60mm/year infiltration assumed. Homogenous permeability with constant permeability regardless of matric suction

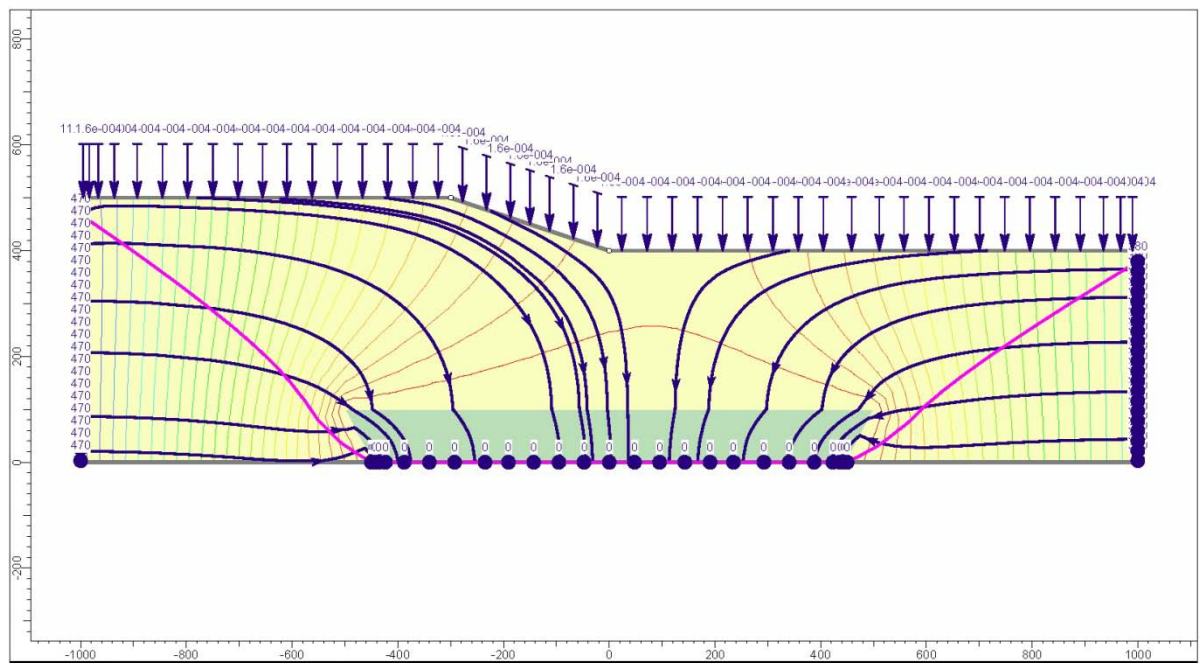
Fig 3b: Flow regime after mining 900m width of longwall panels. Goaf permeability 1000 times that of remainder of overburden, which is taken as being unaffected by mining; Permeability taken as constant regardless of matric suction.

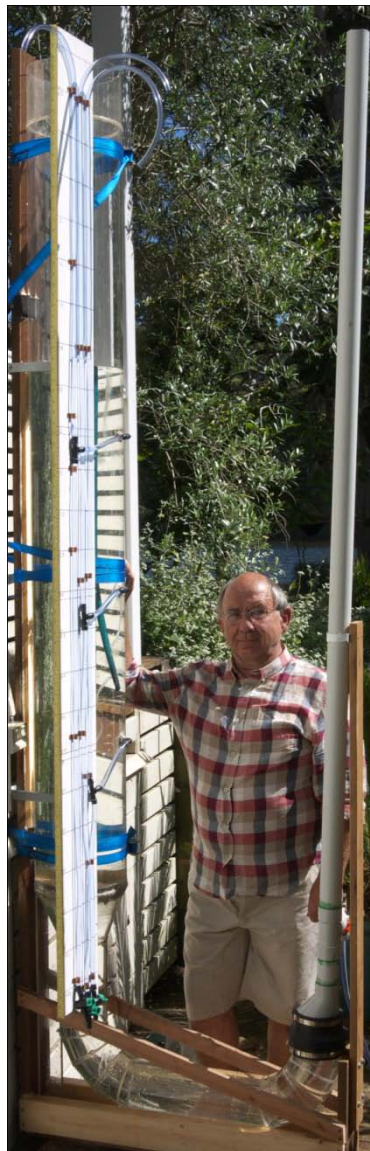
Our column was made of Perspex, 240mm internal diameter. The sand column was just less than 2m high, and included 3 water monomers, 385mm; 781mm and 2183mm above the base of the sand (see Fig 5)

Fig 5: Apparatus before filling with sand; the Perspex column is full of water. The pipe on the right was to allow filling from the base under controlled conditions.

The interesting, and initially unexpected part of the experiment was when, with constant upper head level, the conditions at the base of the column were changed to cascading flow. (See Fig 5). Three things happened:

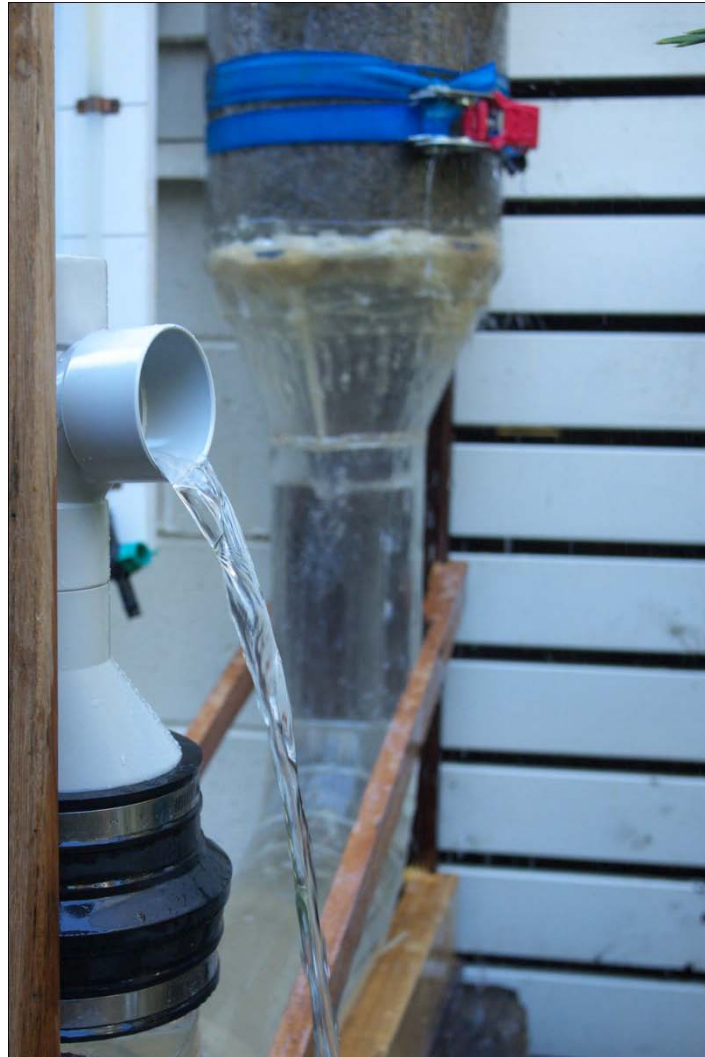
Figure 6 shows the flow from the column during the final test when flow was allowed to cascade from the base of the sand column.

Fig 6: Final test; water allowed to cascade from base of column. The equilibrium position was that the water level at the outlet flow point (atmospheric pressure) was 35mm above the level into which the water from the column was cascading, presumably flow head converted to static head.

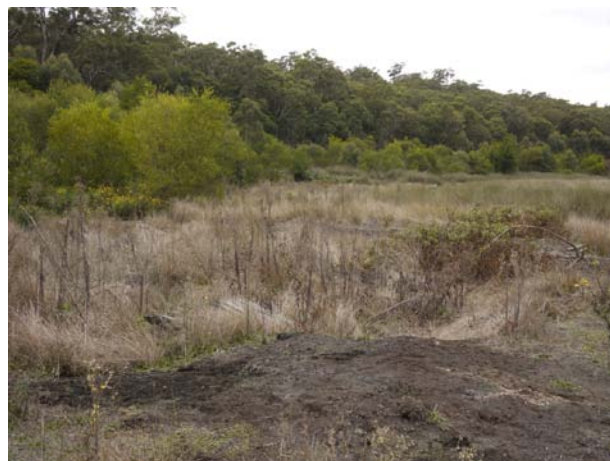
Photo 3: Lake Nerrigorang - Peat at forefront of picture (very spongy under foot).

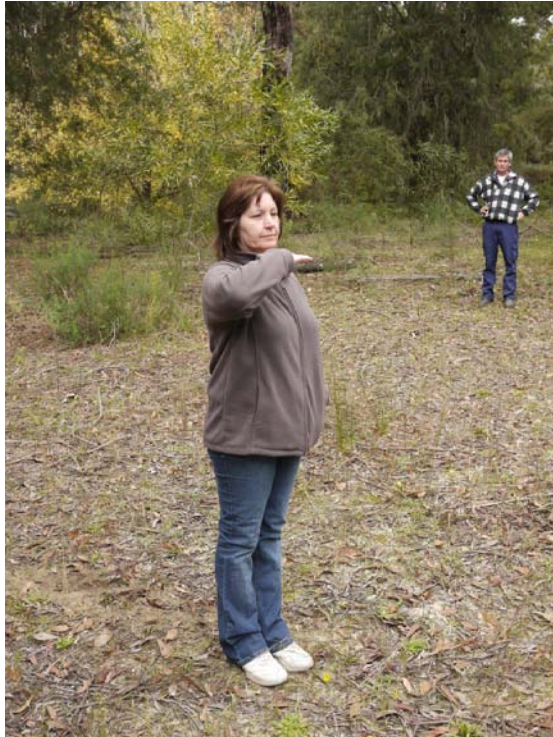
Photo 4: Lake Nerrigorang – Helen Squires and Paul Rackleyft stated the lake level in 1985 was at Helen’s feet and in 1989 level with Helen’s neck (full and equal to overflow pipe in Blue Gum Creek).

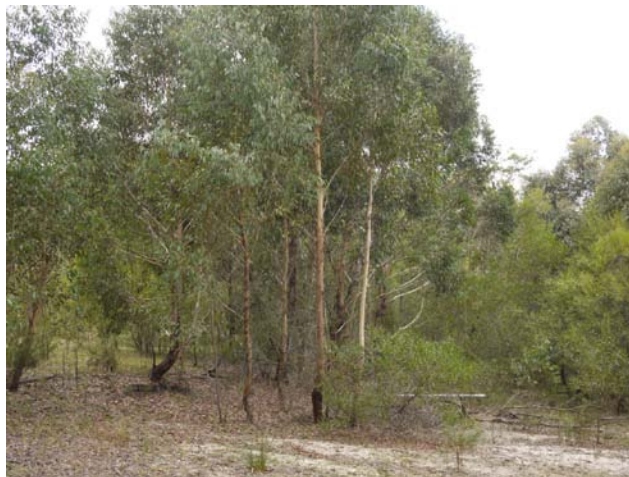
Photo 5: Lake Nerrigorang - Indicates vegetation growth of trees in last 15 years since water has receded (the white sand was put there by Win Racklyeft to create a beach).

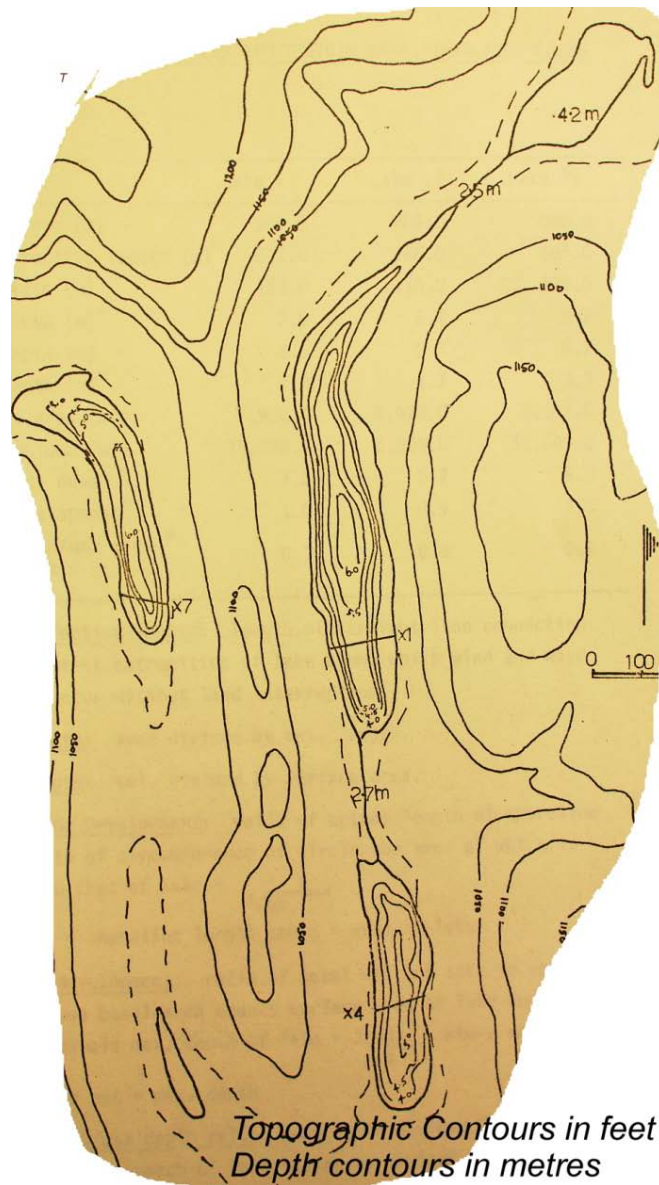
Fanning undertook depth measurements across what she called Lakes 1,2 and 4; the present names being Werri Berri, Couridjah and Nerrigorang. Her hydrographic contours are reproduced in Figure 1 (Figure 3.1 of the Thesis).

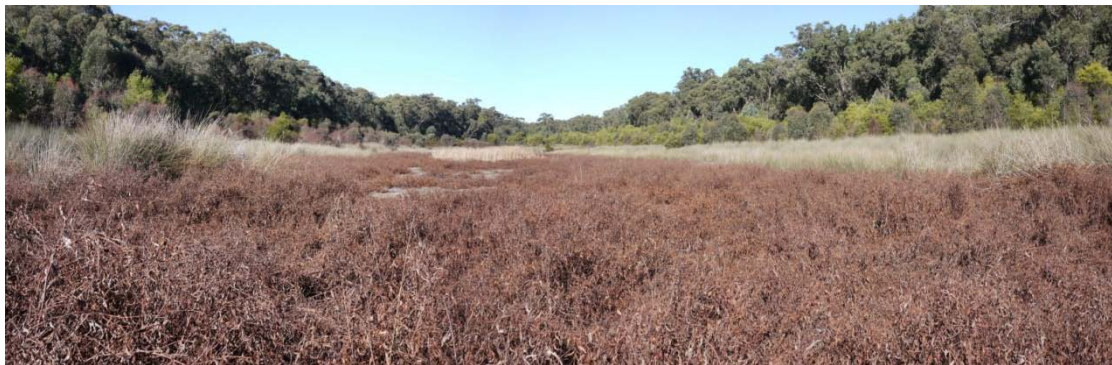
Photograph 1: Lake Nerrigorang, August 2011, P. Pells photo.

At the time of the work Lake Nerrigorang was empty (see Photograph 1), Lake Werri Berri was effectively empty (see Photographs 2 and 3), Lake Couridjah had a maximum water depth of about 0.5m, and "Dry Lake" (Gandangarra) was dry.

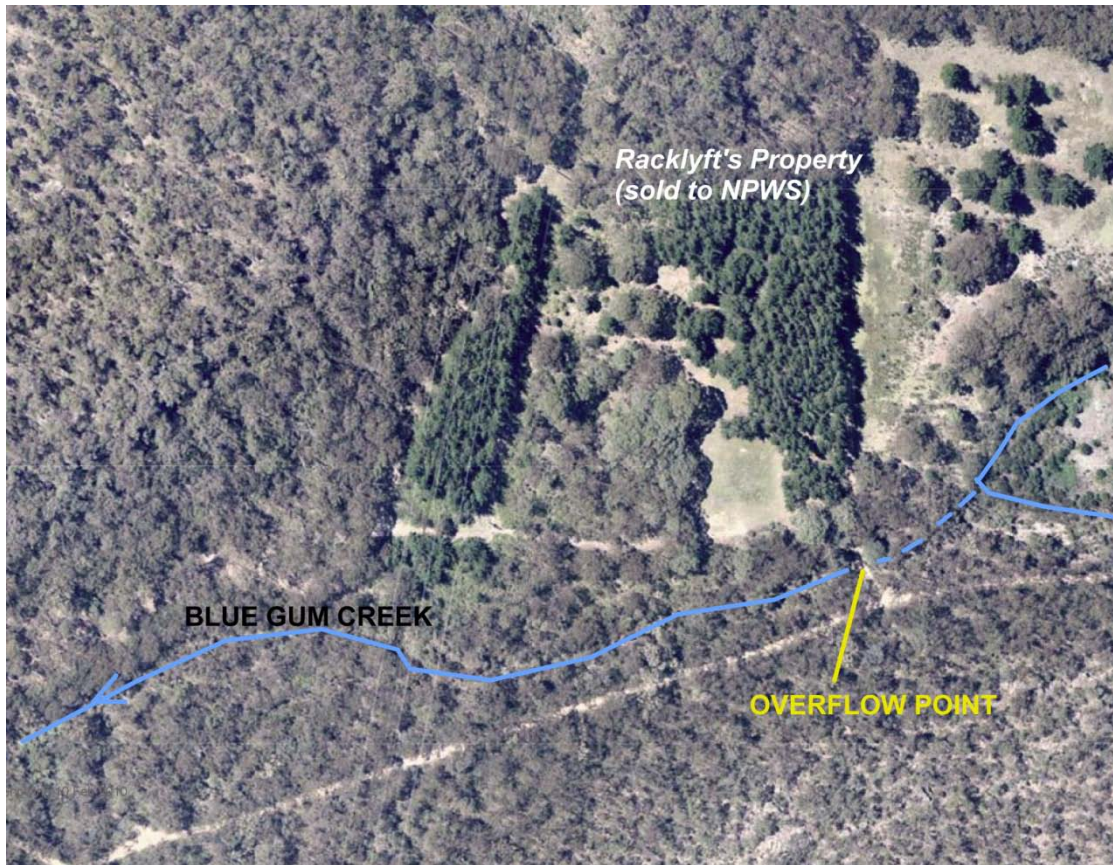
Photograph 4: Overflow point between Lake Nerrigorang and Blue Gum Creek.

Photograph 4 shows the position of the overflow point between Lake Nerrigorang and Blue Gum Creek.

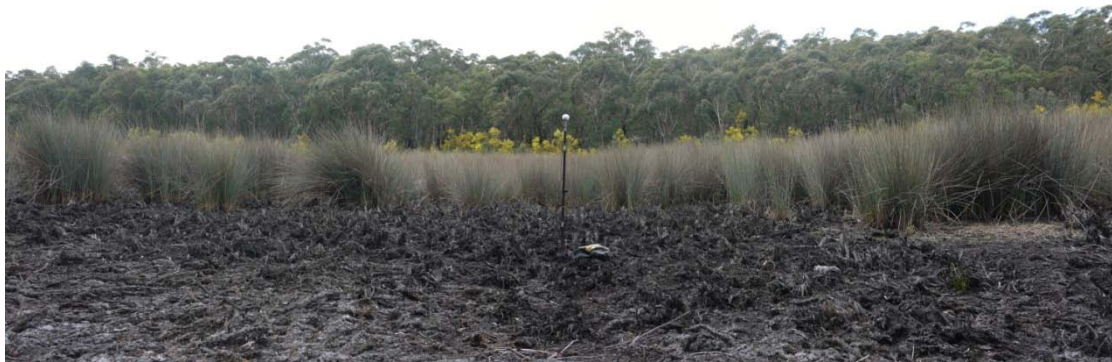
Photograph 5: Lake Baraba, 22 August 2011 (P. Pells photo).

It transpires that the level of the peat in Lake Baraba (see Photograph 5) is at or above the full water levels of the other lakes. In fact, the peat level in Lake Baraba is about 7m above the floor level of Lake Nerrigorang. Lake Baraba is, actually, a valley fill swamp and is discussed further in Section 9.

The survey solved one puzzle, namely: why does Lake Baraba never fill up?

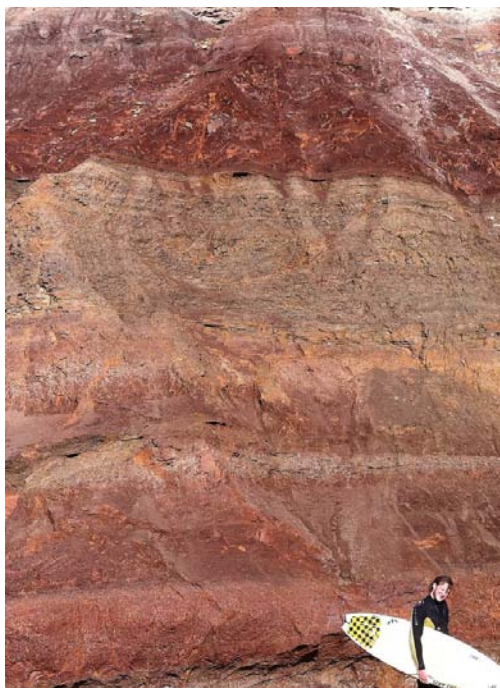
Photograph 19: Bald Hill Claystone at Long Reef, Sydney

The Bald Hill Claystone is an approximately 20m thick layer of interbedded, siltstone, claystone and fine sandstone comprising mainly kaolinite and haematite. It contains as many as eight soil profiles² (ie. eight superimposed palaeosols), is fissured and jointed, and is transgressed (in places) by faults and igneous intrusions (see Photographs 19 to 21).

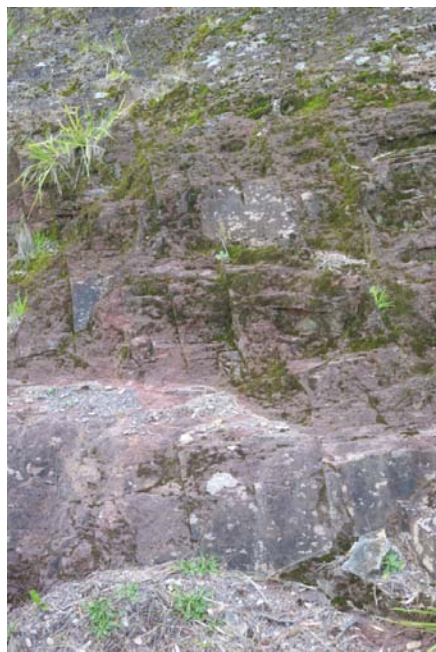
Photograph 20: Joints in Bald Hill Claystone at Bald Hill

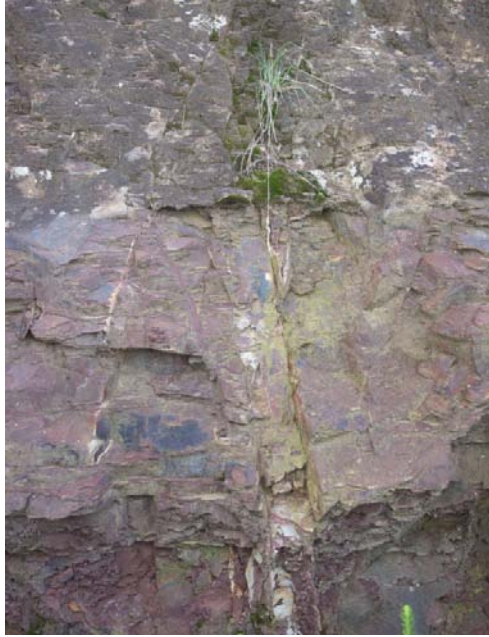
Photograph 21: Through going joint in the type section at Bald Hill, just north of Stanwell Park.
