REPORT ON THE WATER LEVELS OF THIRLMERE LAKES

P053.R1

THE WATER LEVELS OF THIRLMERE LAKES

This report addresses the question as to why Lakes Gandangarra, Werri Berri, Couridjah and Nerrigorang contained almost no water as of October 2011; with Nerrigorang having dried completely by December 2009, and Gandangarra and Werri Berri by September 2011. Is this a natural, climate phenomenon, or have some other influences come to play?

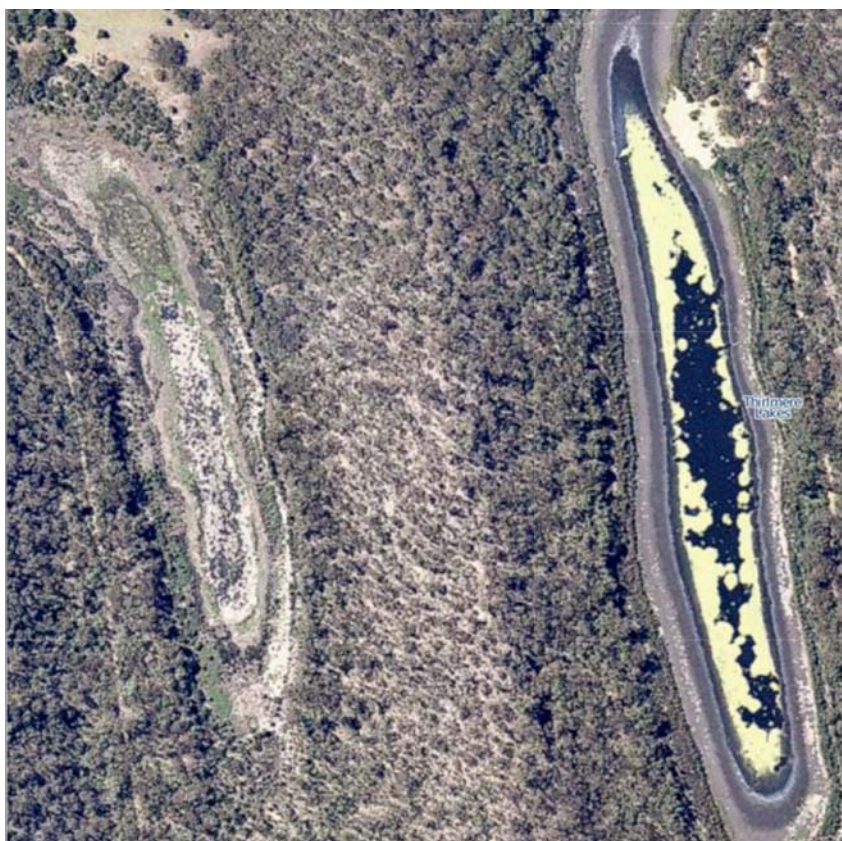
Figure 1.11: Lake Nerrigorang (left) and Lake Werri Berri (February 2010) – Near Map Photo.

In early February 2010, Lake Nerrigorang was empty and Lake Werri Berri contained less than a metre of water and was partly covered in algae (see Figure 1.11). At that time Lake Couridjah still covered about 75% of its full plan area, and Lake Baraba was as it always is, a swamp with a small central pond (see Figure 1.12).

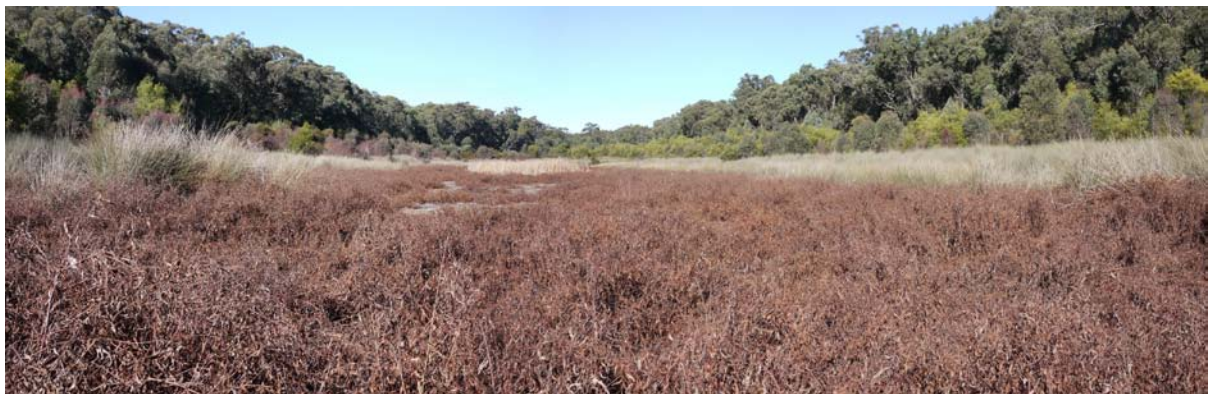
Figure 1.13: Lake Nerrigorang, June 2011 (Pells photo).

In June 2011, Lake Nerrigorang was still empty (see Figure 1.13) and was the same in September 2011 (see Figure 1.14).

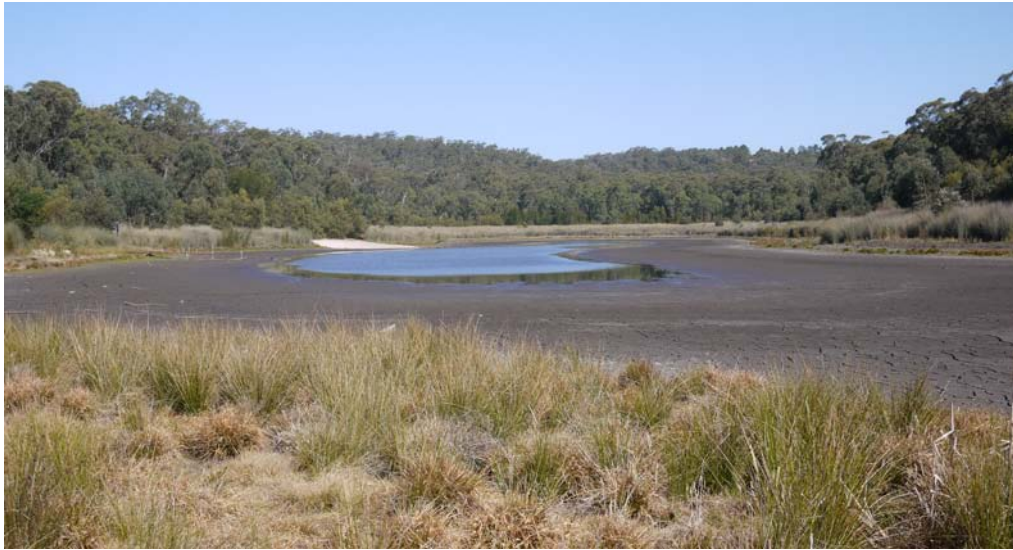
Figure 1.16: Lake Couridjah, 22 September 2011 (Pells photo).

On 22 September 2011, Lake Couridjah contained less than 100mm depth of water in its central area (see Figure 1.16).

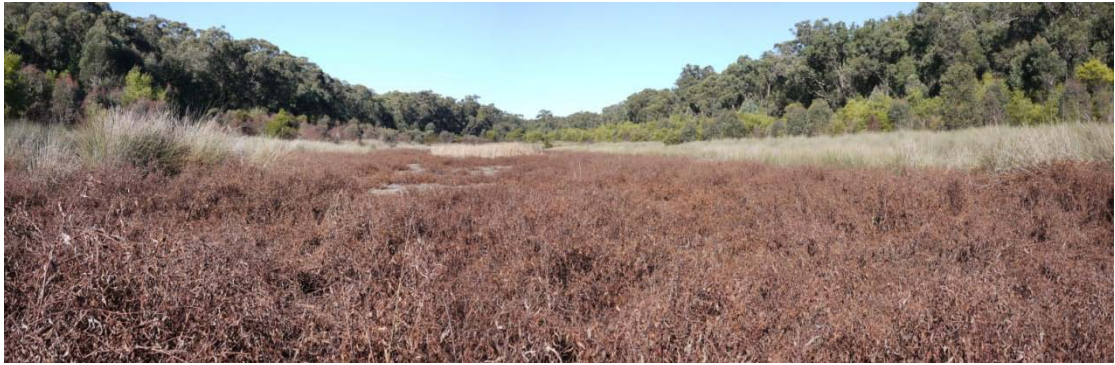
Figure 2.2: Lake Nerrigorang, August 2011, P. Pells photo.

At the time of the work Lake Nerrigorang was empty (see Figure 2.2), Lake Werri Berri was effectively empty (see Figures 2.3 and 2.4), Lake Couridjah had a maximum water depth of about 0.5m, and "Dry Lake" (Gandangarra) was dry.

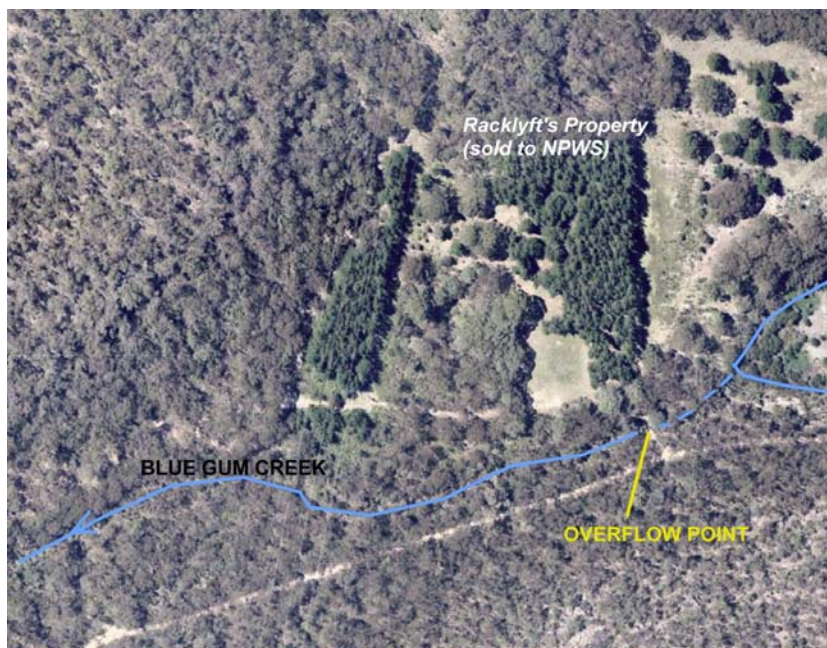
Figure 2.5: Overflow point between Lake Nerrigorang and Blue Gum Creek.

Figure 2.5 shows the position of the overflow point between Lake Nerrigorang and Blue Gum Creek.

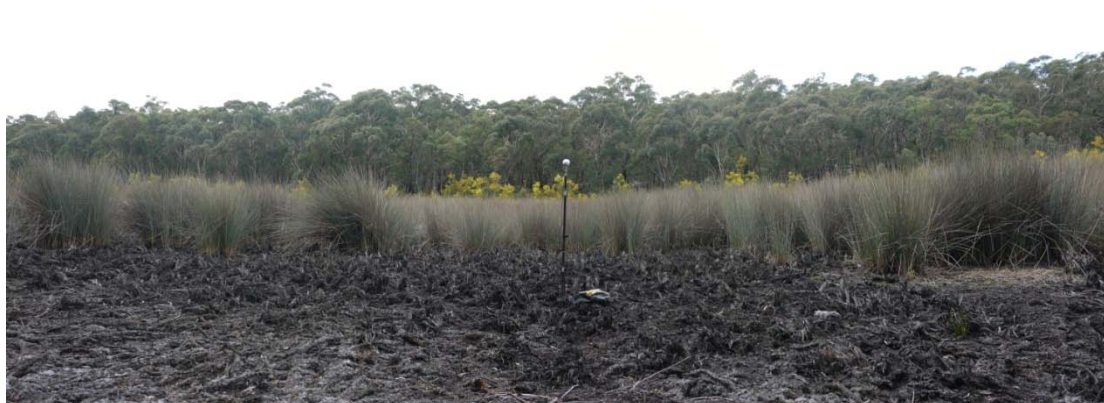
Figure 2.8: Lake Baraba, 22 August 2011 (P. Pells photo).

It transpires that the level of the peat in Lake Baraba (see Figure 2.8) is at or above the full water levels of the other lakes. In fact, the peat level in Lake Baraba is about 7m above the floor level of Lake Nerrigorang. Lake Baraba is, in effect, a valley fill swamp.

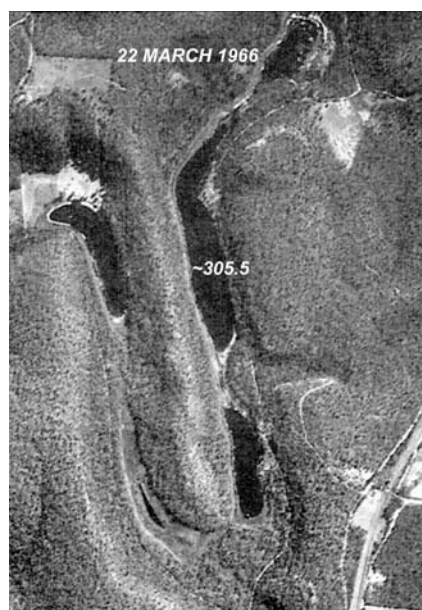
Figure 2.9: 22 March 1966 with level.

Figure 2.9 is one example showing the assessed level in Werri Berri based on the aerial photograph of 22 March 1966.

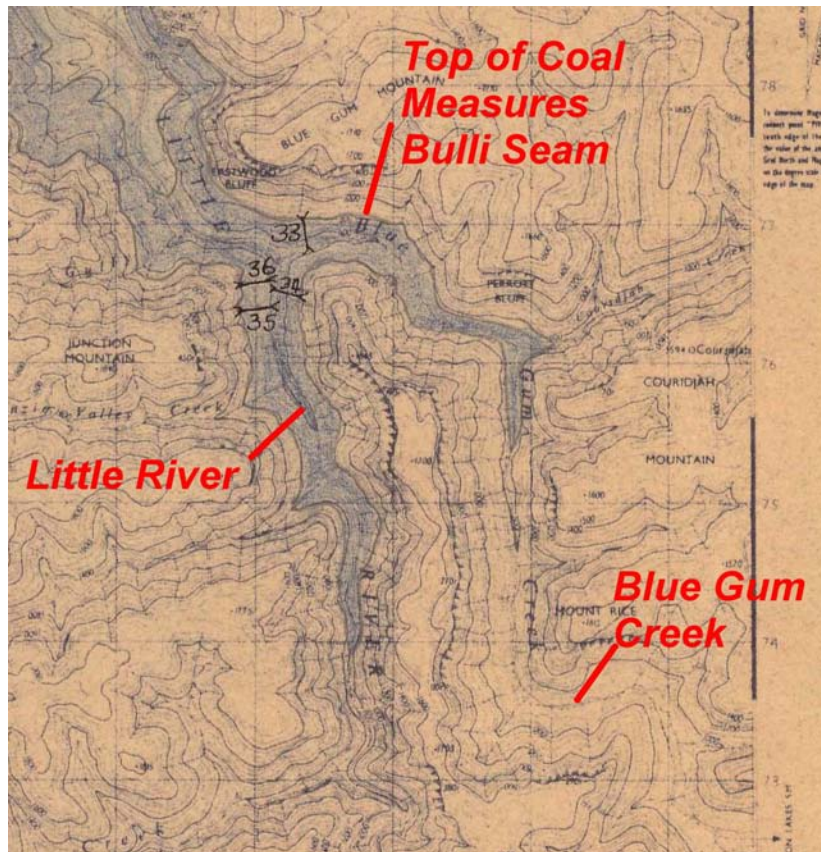
Figure 3.2: 1969 geological map of the Burragarang Valley showing outcrop geology.

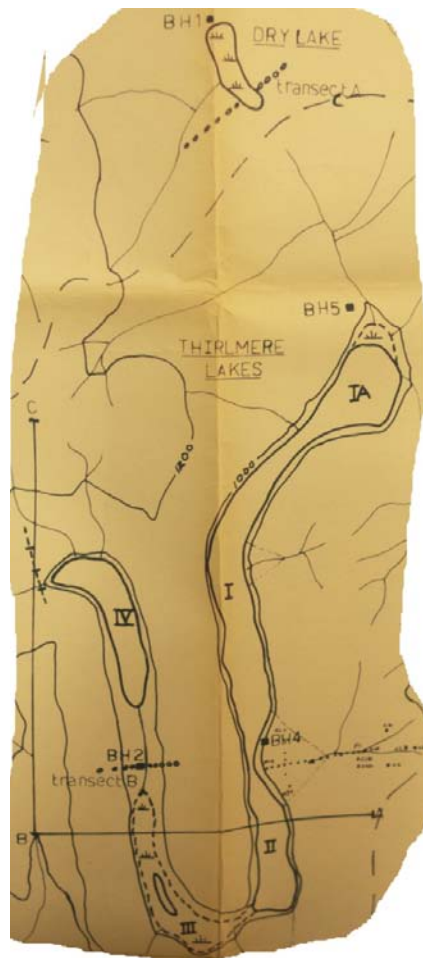
Figure 3.4: Location of boreholes.

The locations of the boreholes are shown in Figure 3.4. Summary logs of the boreholes are given in Table 3.2 and shown diagrammatically in Figure 3.5.

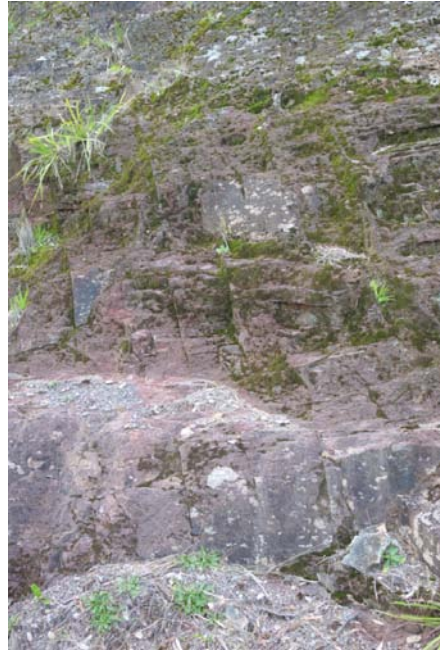
The Bald Hill Claystone contains as many as eight soil profiles²⁵ (ie. eight superimposed palaeosols), is fissured and jointed, and is transgressed (in places) by faults and igneous intrusions (see Figures 3.11 to 3.13).

Figure 3.12: Joints in Bald Hill Claystone at Bald Hill

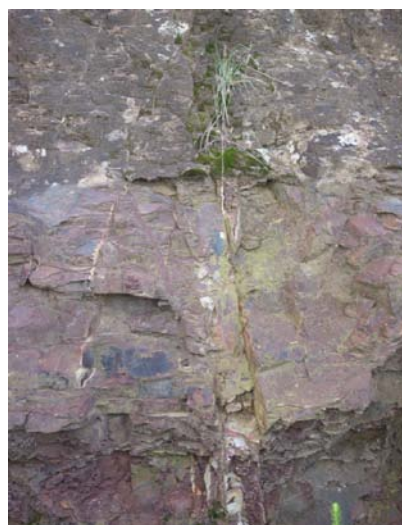
Figure 3.13: Through going joint in the type section at Bald Hill, just north of Stanwell Park.

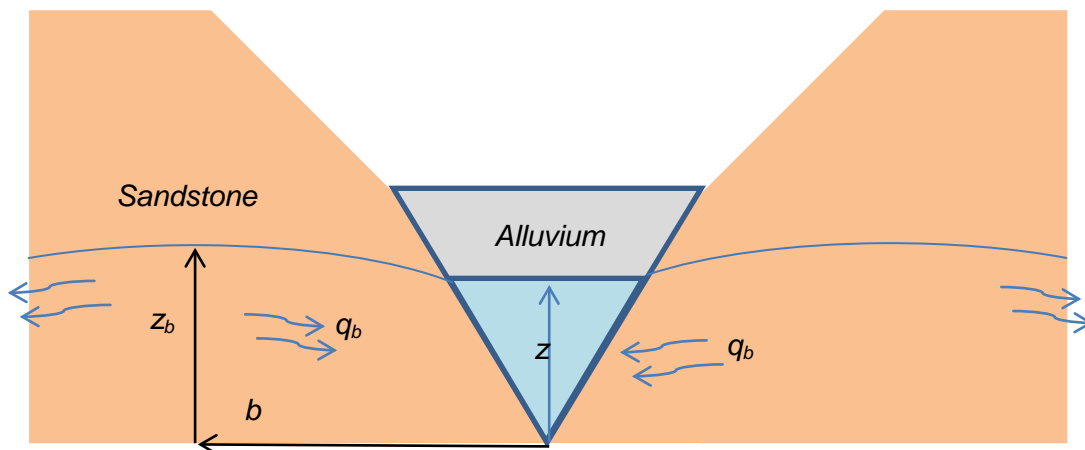
Figure 5.6: Groundwater seepage.

Secondly, the occurrence of baseflow from the surrounding sandstone formations and towards the lake is of interest. This can be estimated with Dupuit's formula as shown in Figure 5.6 and Equation 3.

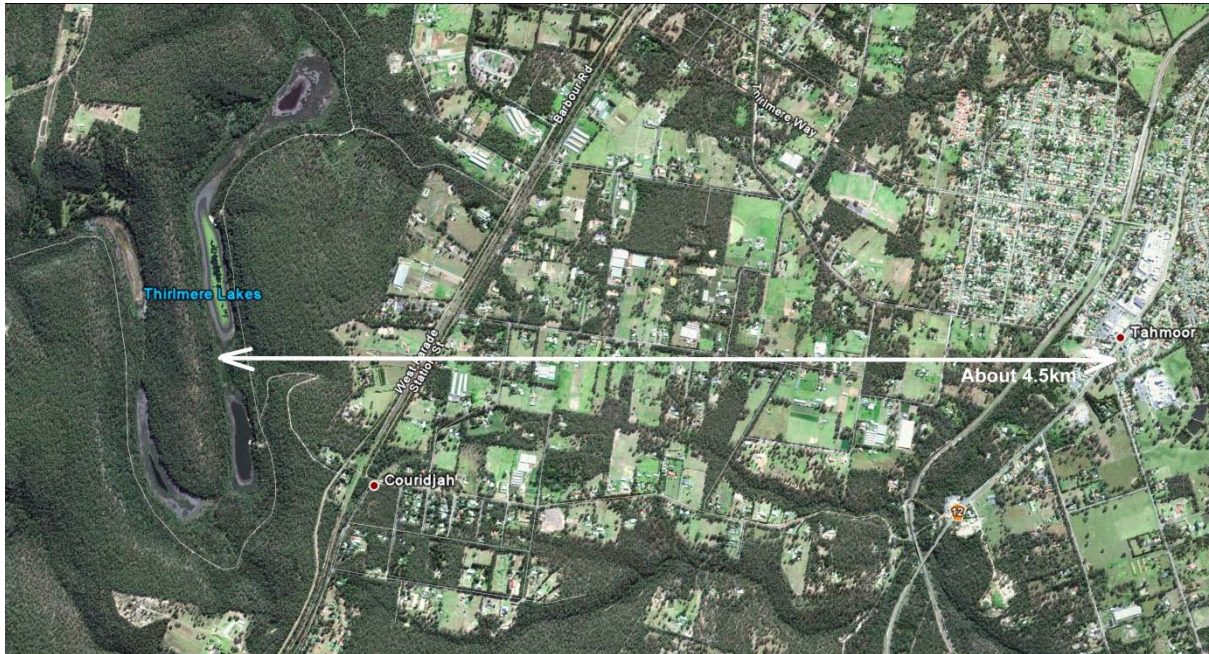
Figure 6.1: Area considered for groundwater assessment.

This chapter deals with the groundwater regime in the area from the Thirlmere Lakes to about the town of Tahmoor (See Figure 6.1).

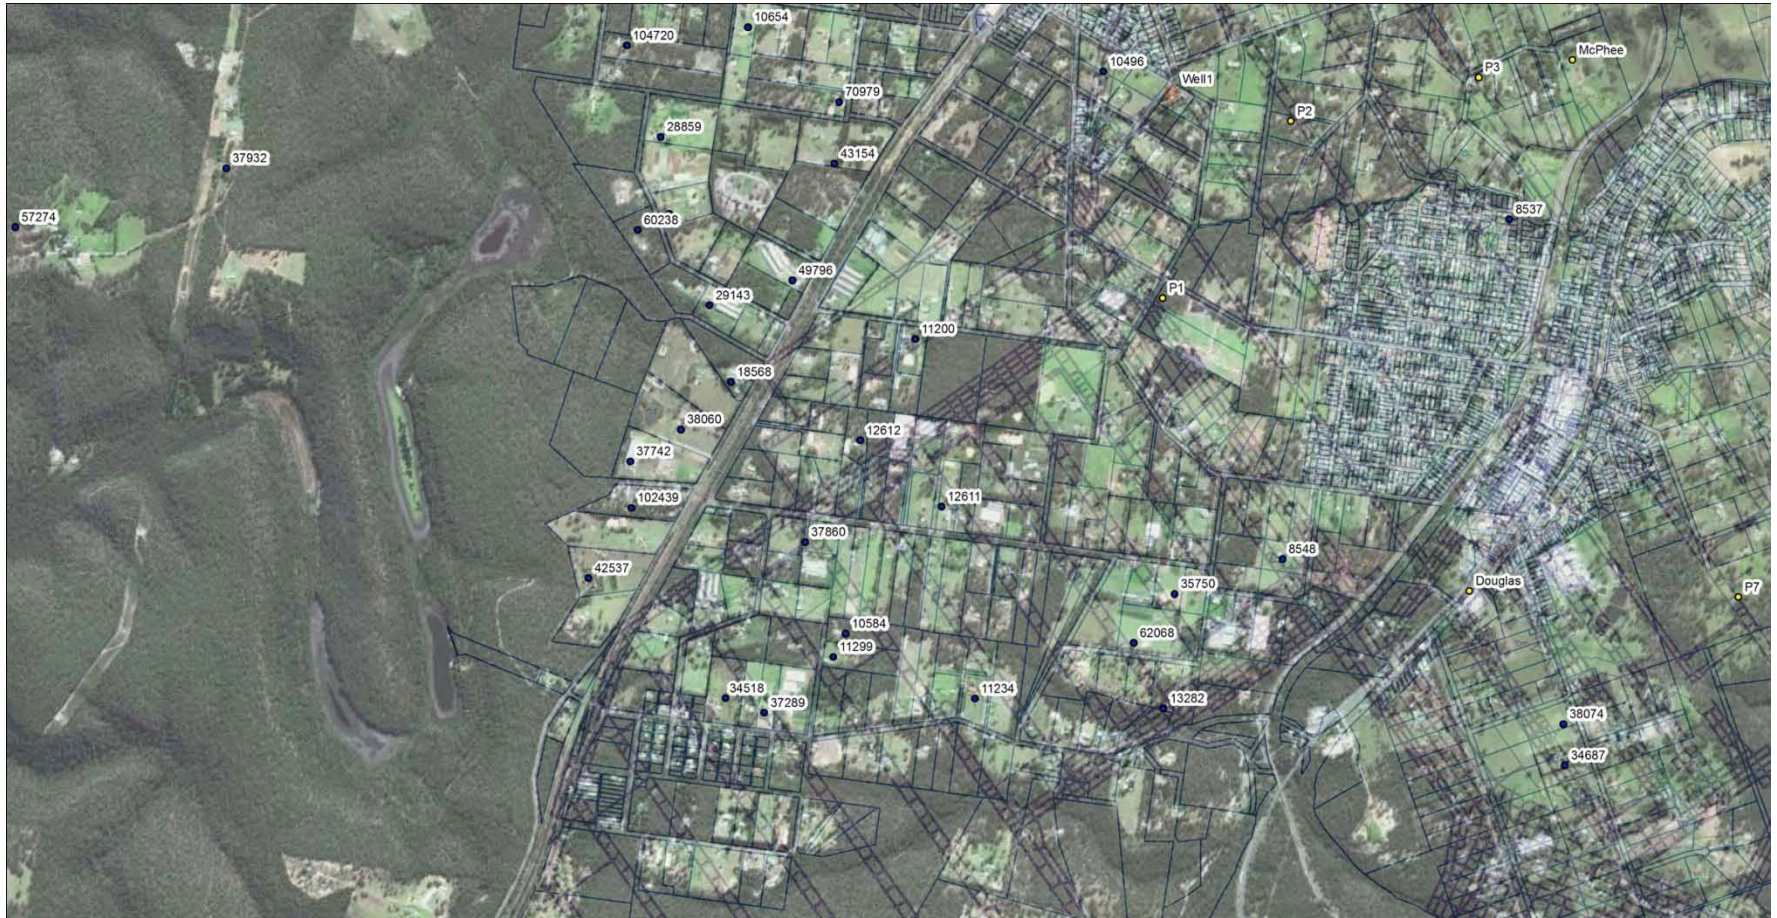
Figure 6.4: Locations of registered bores.

Figure 6.4 shows the locations of private bores recorded on the NSW government database.

On 22 September and 4 October 2011, visits were made by personnel from Pells Consulting to speak to the owners of most of the bores shown on Figure 6.4. The owners could not be contacted at the following sites: 18568, 34518, 37289, 10584, 60238 and 34518.

The impacts have been substantial. Bores of 60m to 120m depth, with registered yields of up to 3 litres per second are reported to have lost all or most of the yield in the periods corresponding with longwall mining beneath, or near, to the bore locations.

Equally well, the following bores are considered by their owners as having not been affected: 29143 and 11299, although the latter owner had only owned the property subsequent of it being undermined.
